# Microelectronics company saves more than just data with Nalco Water

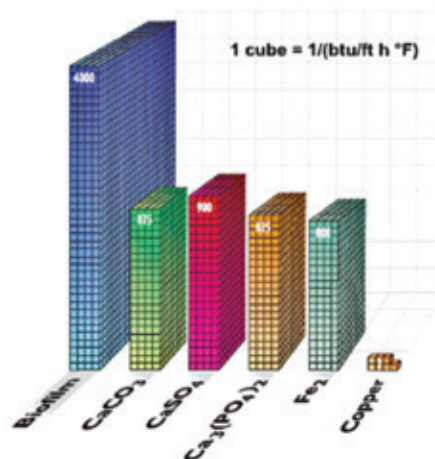
**FIGURE 3:** MICROBIAL BIOFILMS AND COMMON SCALE GREATLY REDUCE THE HEAT TRANSFER EFFICIENCY OF ANY HEAT EXCHANGE SURFACE

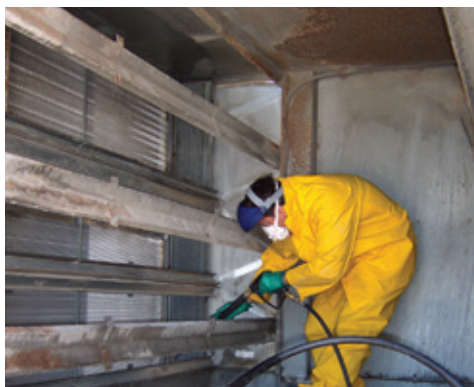
FIGURE 7: IS A TYPICAL CLEANING IN PROCESS

There are more than 200 air handlers at the customer's facilities. Using Nalco Water's COIL-FLO™ cleaning process, the coils in the air handlers were cleaned. This method, which uses a patented low-water volume, medium-pressure cleaning solution, has distinct advantages over other commonly used techniques:

Figure 7 shows an example cleaning in process, and Figure 8 shows an example of the before-and-after data comparison of energy consumption and reduced pressure loss through the filter bank.

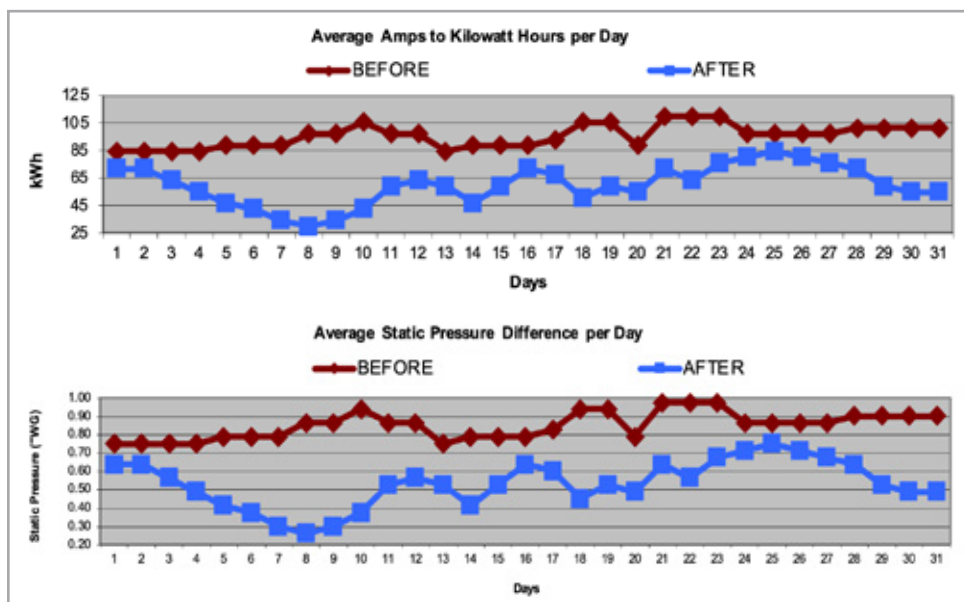
FIGURE 8: BEFORE-AND-AFTER DATA COMPARISON

- Avg. 0.67 in. static pressure reduction (H<sub>2</sub>O)
- 8,760 hours operation per year
- Avg. 36.67 kw/hr saved
- \$122,197 per year minimum annual electrical savings
- CO<sub>2</sub> reduction: 1,682,474 lbs/year

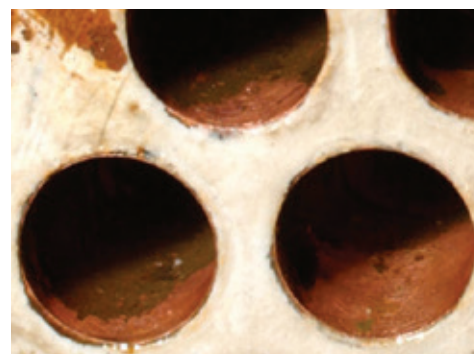
FIGURE 10: AFTER THE CLEANING, THE CHILLER'S HEAT EXCHANGE EFFICIENCY WAS COMPLETELY RESTORED

The technology entirely removed the deposit in some areas, or so substantially softened it that it could be removed from the chiller just by brushing. Corrosion during the cleaning was essentially zero on mild steel and copper. Figure 10 was the photo taken after the cleaning.
